Manhole Inspection Summary

Manhole # S33E__002MH

Insp Date: **2/10/09 1:38 PM**

Location Address: **fayette st**

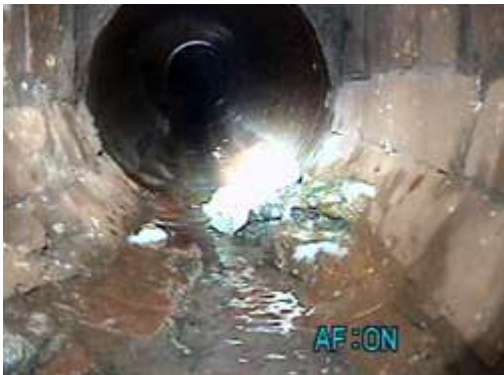
Misc

channel debris

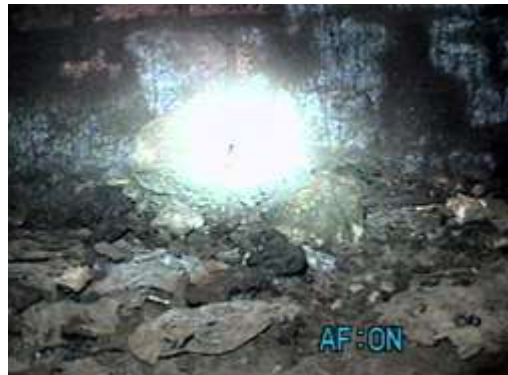
Defect 2

Condition: ☐ Sound ☐ Cracked ☐ Root Intrusion ☐ Deteriorated ☐ Leaks ☒ **Debris**

bench debris

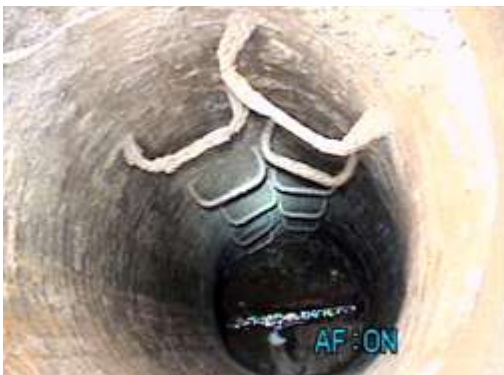
Defect 1

Steps Count: **12** Missing: **0** ☒ **Corroded**

cor.steps

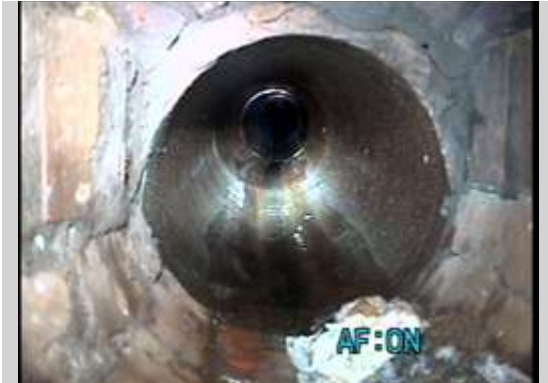
12 O'Clock Outflow

10 in. Circular Gravity Sewer
Pipe Out @ 12 O'Clock

Deposits: ☒ None ☐ Mud ☐ Sludge ☐ Debris ☐ Grease

Infiltration: **None** Pipe Seal Cond: **Unknown**

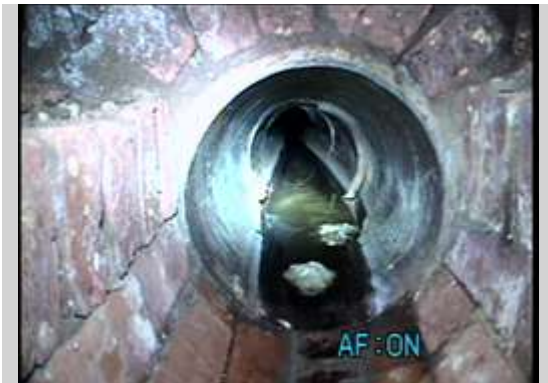
6 O'Clock Inflow

10 in. Circular Gravity Sewer
Pipe In @ 6 O'Clock

Deposits: ☒ None ☐ Mud ☐ Sludge ☐ Debris ☐ Grease

Infiltration: **None** Pipe Seal Cond: **Unknown**
